LPKF ViaCleaner

To remove the activator from every
copper surface

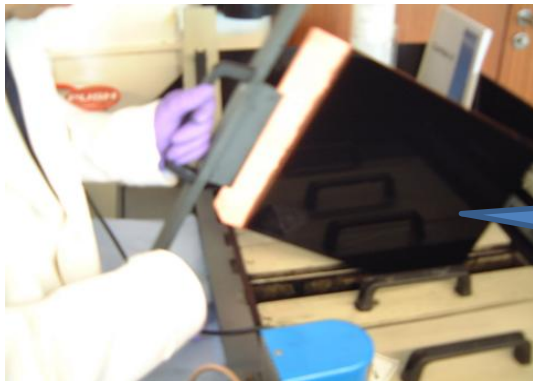
Immediately after activating the board, it has this aspect

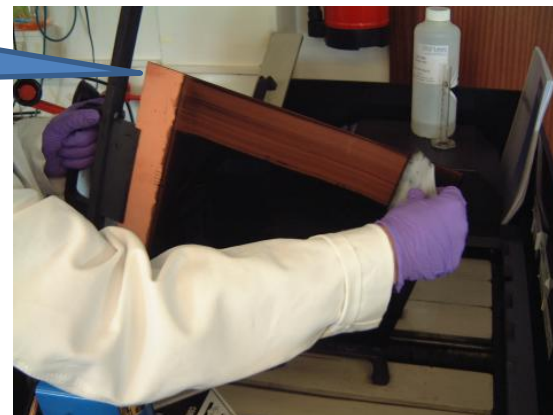
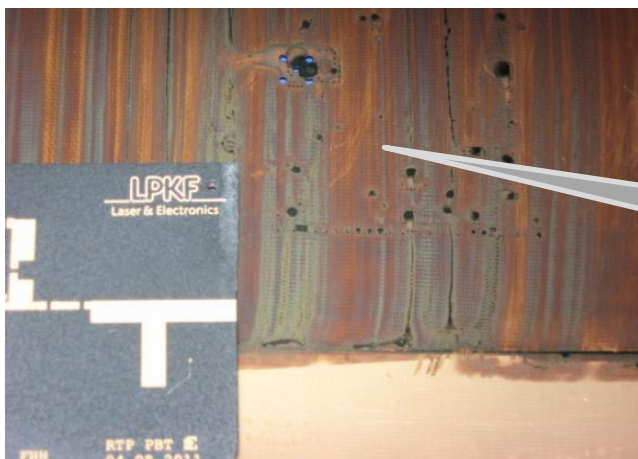
With the squeegee we clean the surface of the PCB from ACTIVATOR rests and give it back to the pool

but these grooves are really horrible

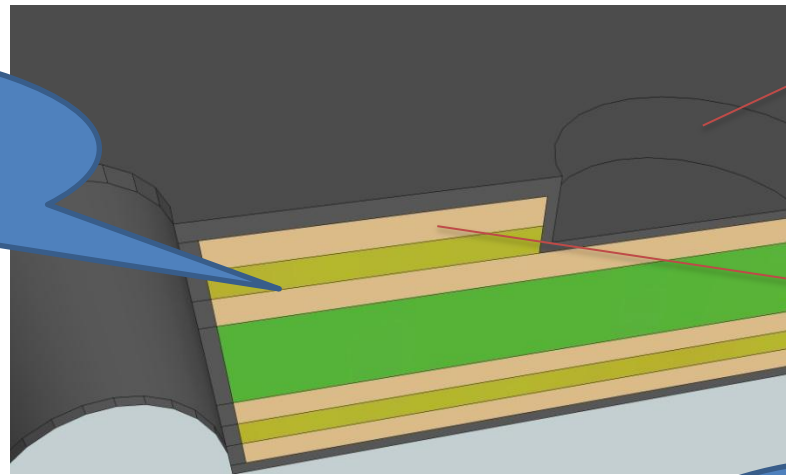
If we could magnify it, the aspect would be very simmilar to this

Activator

Copper

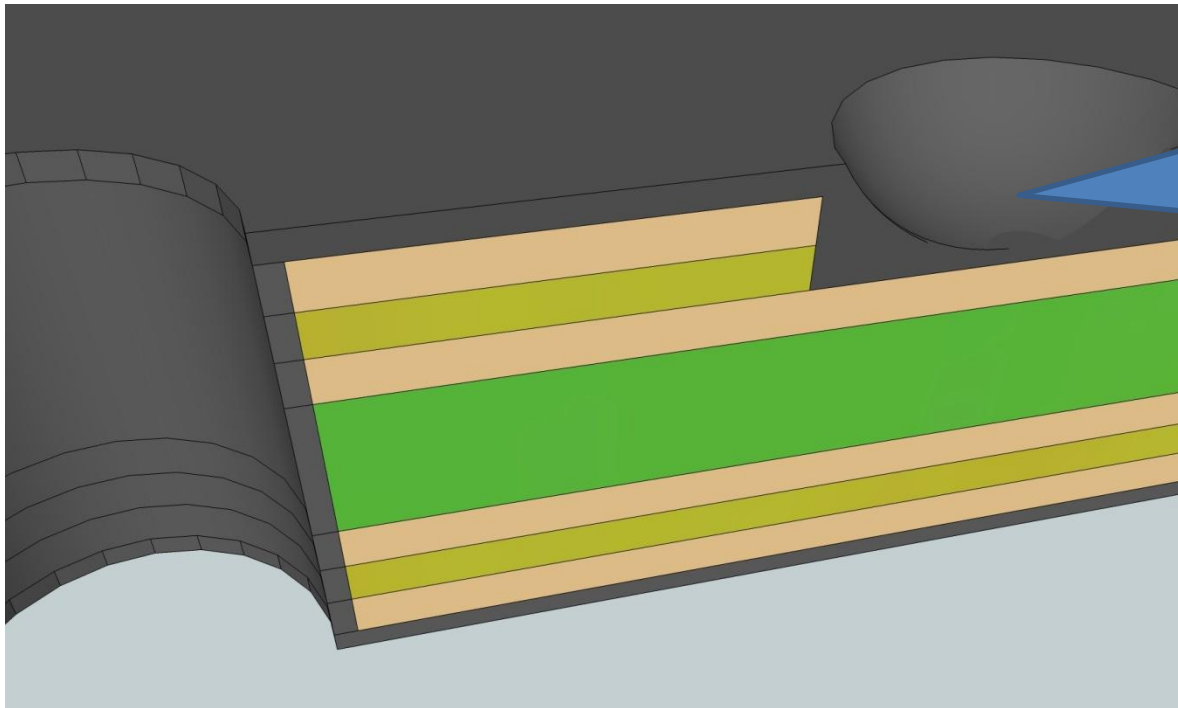
For very small holes, it could be even worse !

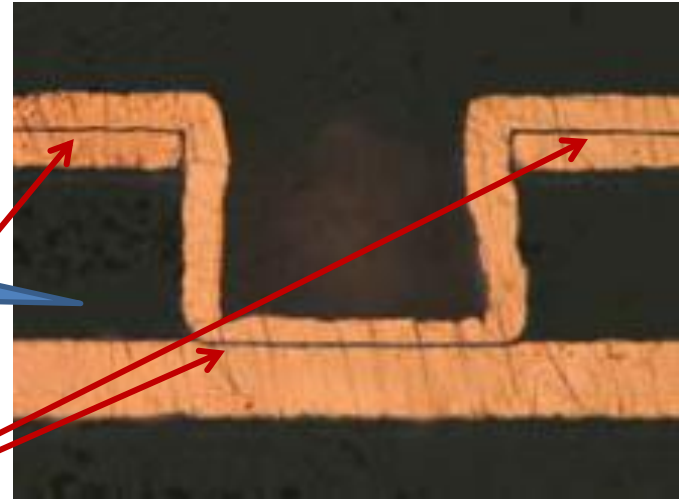
After the galvanic step it could look like that

There still was some carbon from the activator !

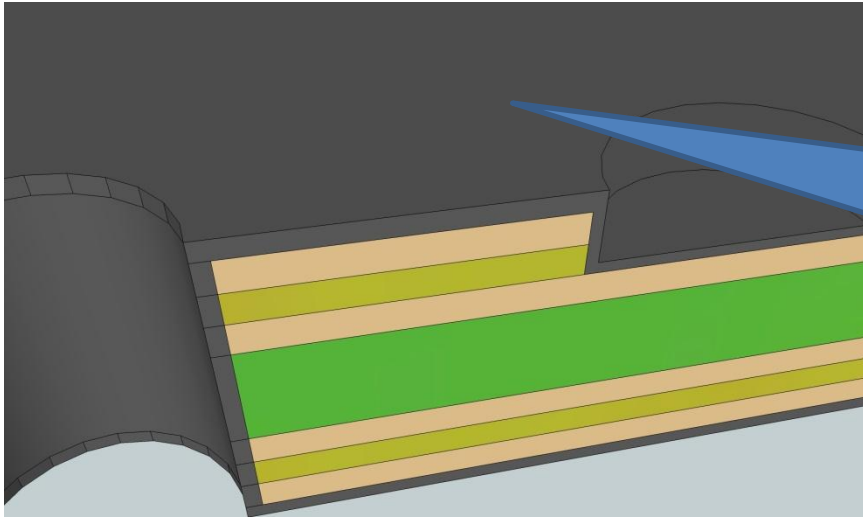
We will remove it.
Let us go back; **after** the activation, but **before** we put the board in the Copper Plate tank

The activator is covering the whole board

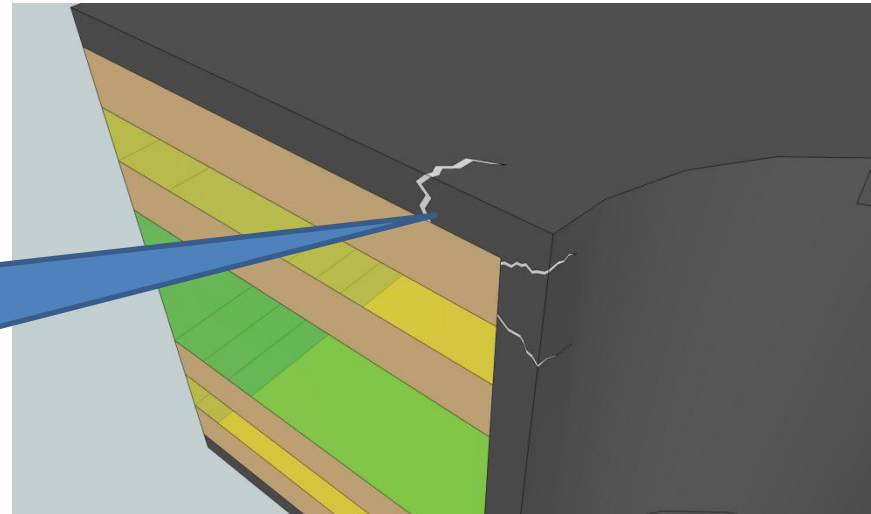
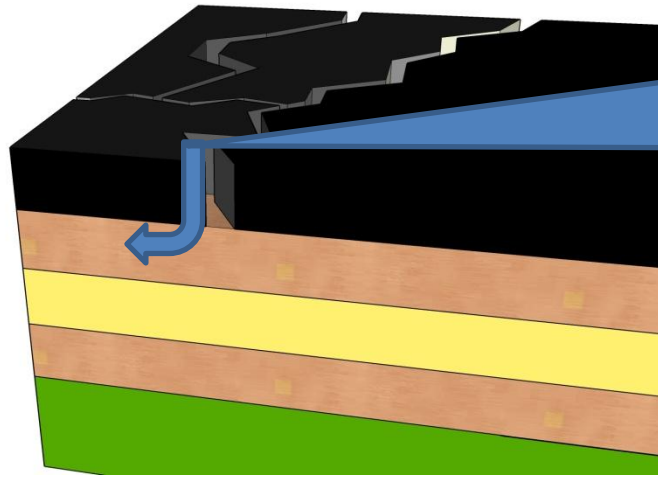
But the activator clad has some *microcracks*

Through this cracks, the acid etches the copper underneath very slightly

and the activator falls off

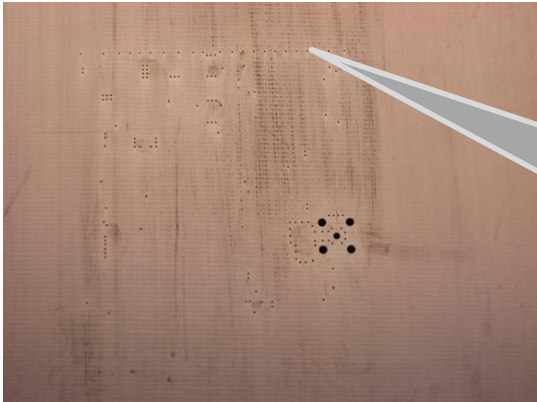
The board surface is much smoother now

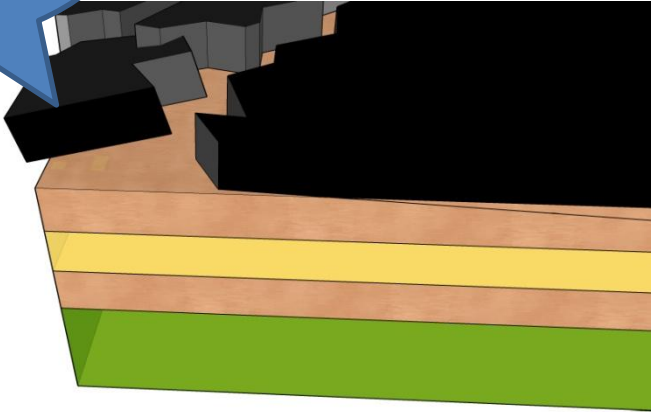
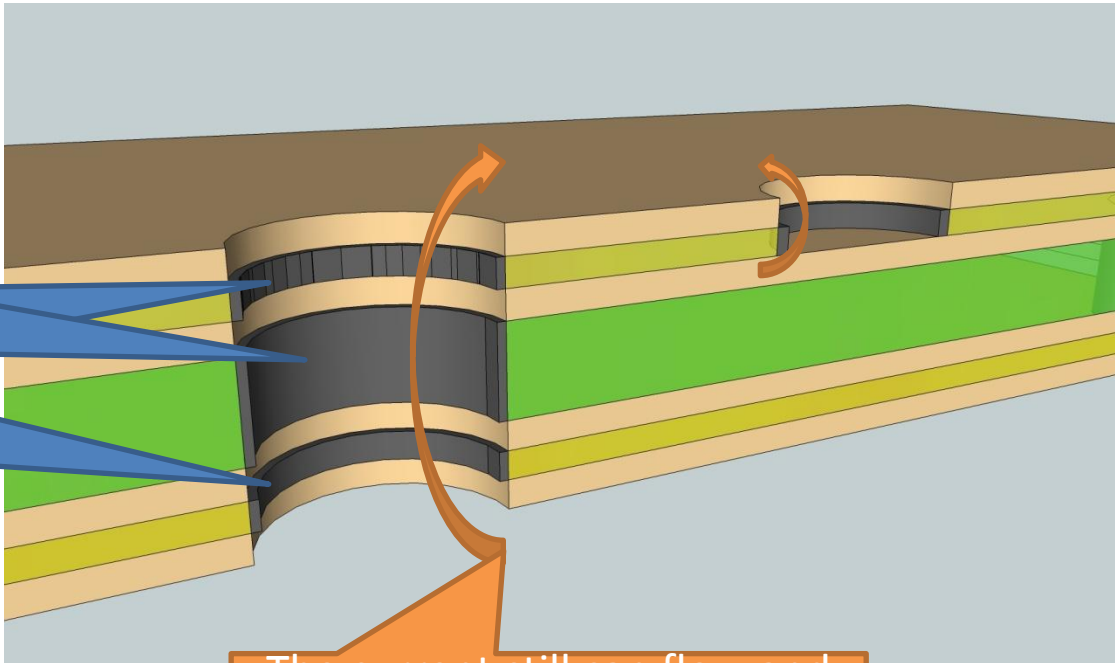
It remains only in the regions where the substrate is underneath

The current still can flow and start the galvanic process

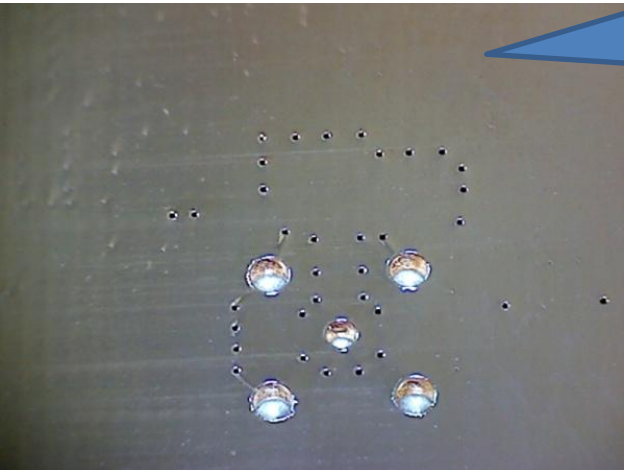
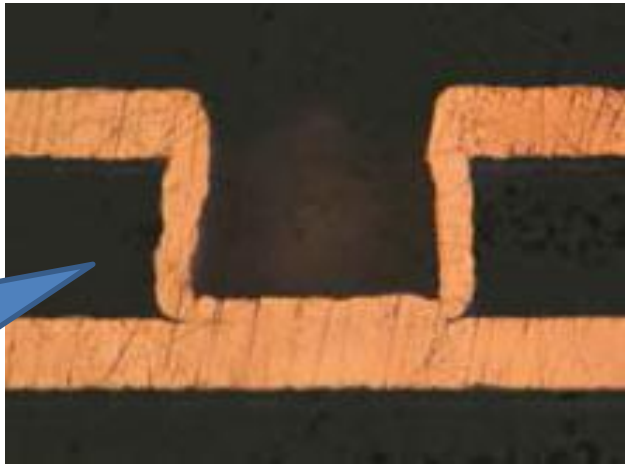
The quality of the plating is much better now...

specially at the blind vias
